## Concrete Supply Company – Mauldin Plant

### Unpermitted Industrial Stormwater Inspection SC

December 11, 2018

SW-CSCMauldin-12/11/18

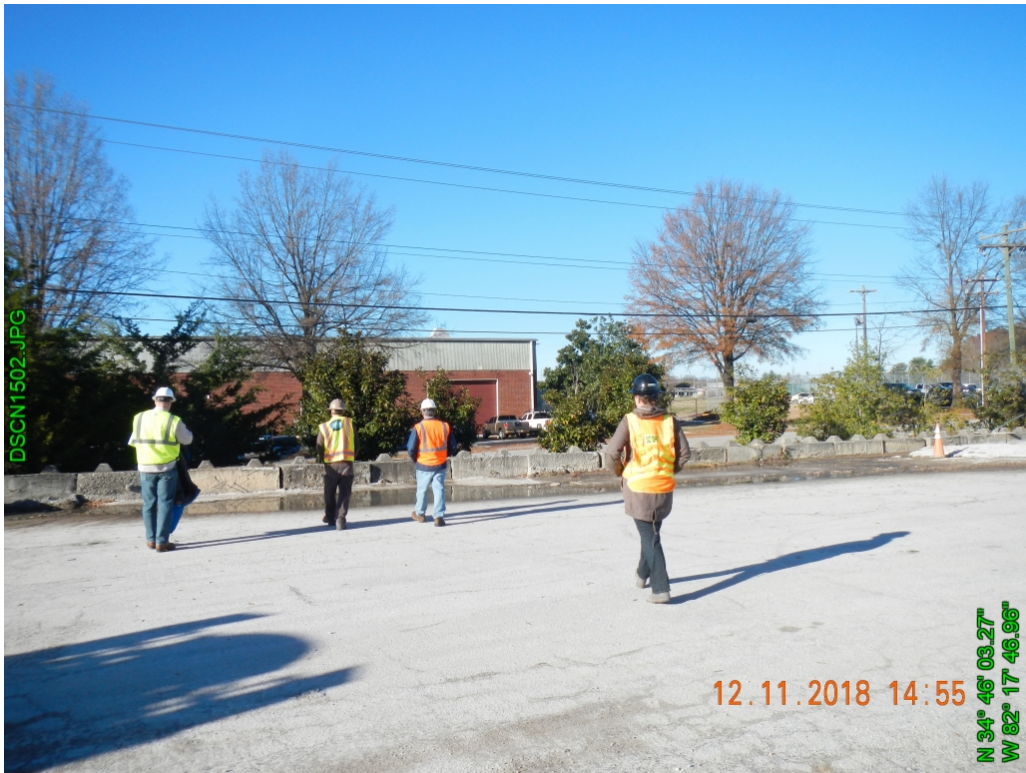
Attributes	
Description	Prior Outfall #1 is at base of wall in background. The facility stated that they have blocked the outfall and no longer treat it as an outfall. Evidence of ongoing drainage off-site at this location was visible from the NW side of the wall.

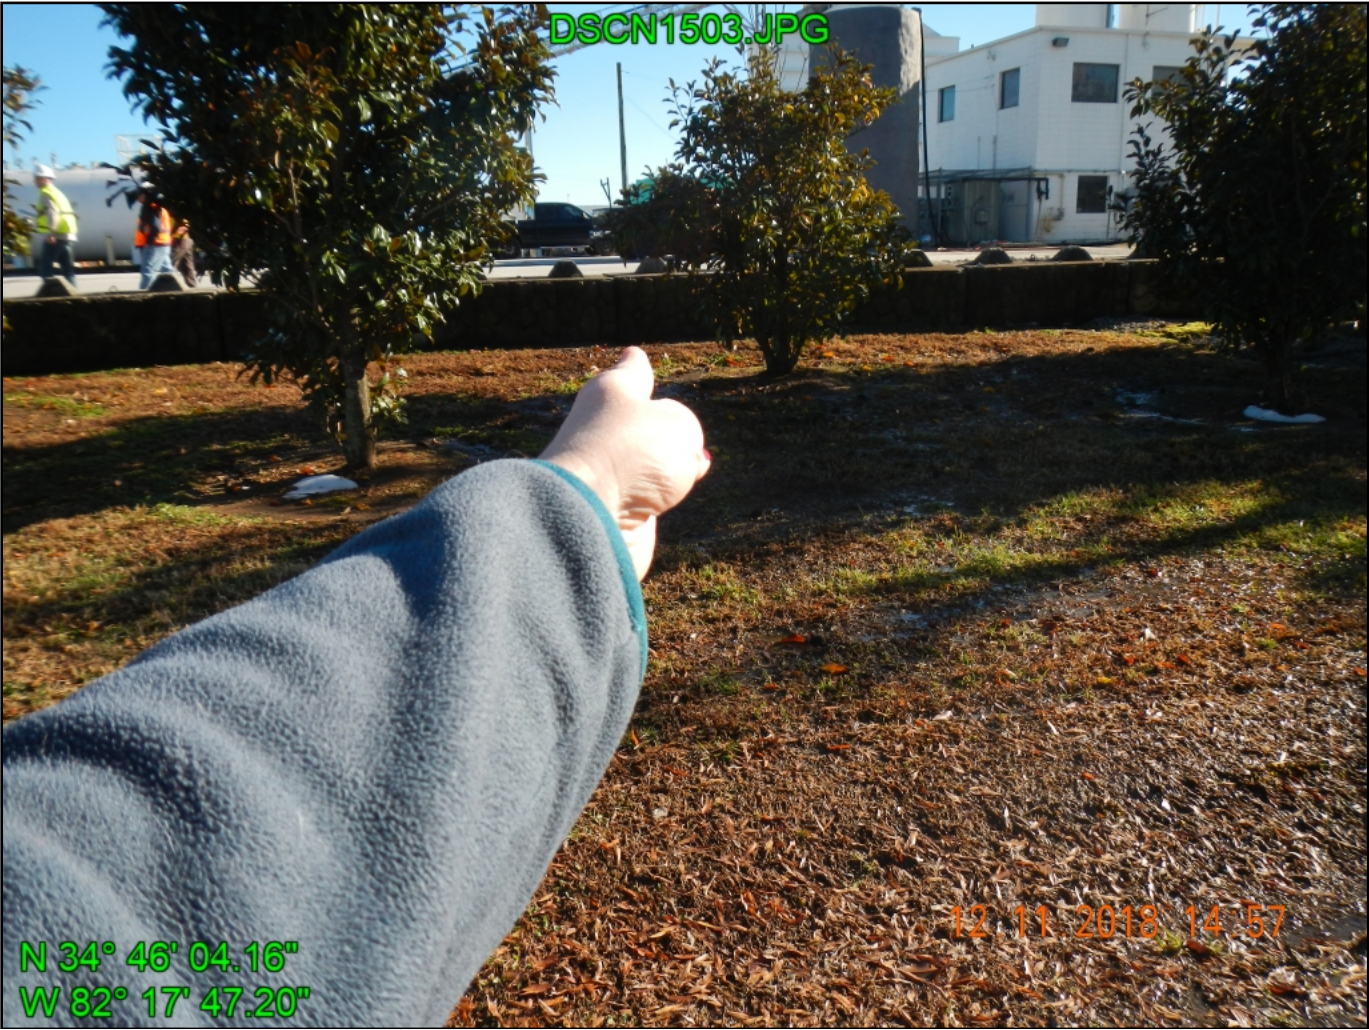
Attributes	
Description	Hand is pointing at location of Outfall #1. The facility stated that they have blocked the inlet to the outfall and no longer treat it as an outfall. Evidence of ongoing drainage off-site at this location was visible on the wet ground in the shadow.

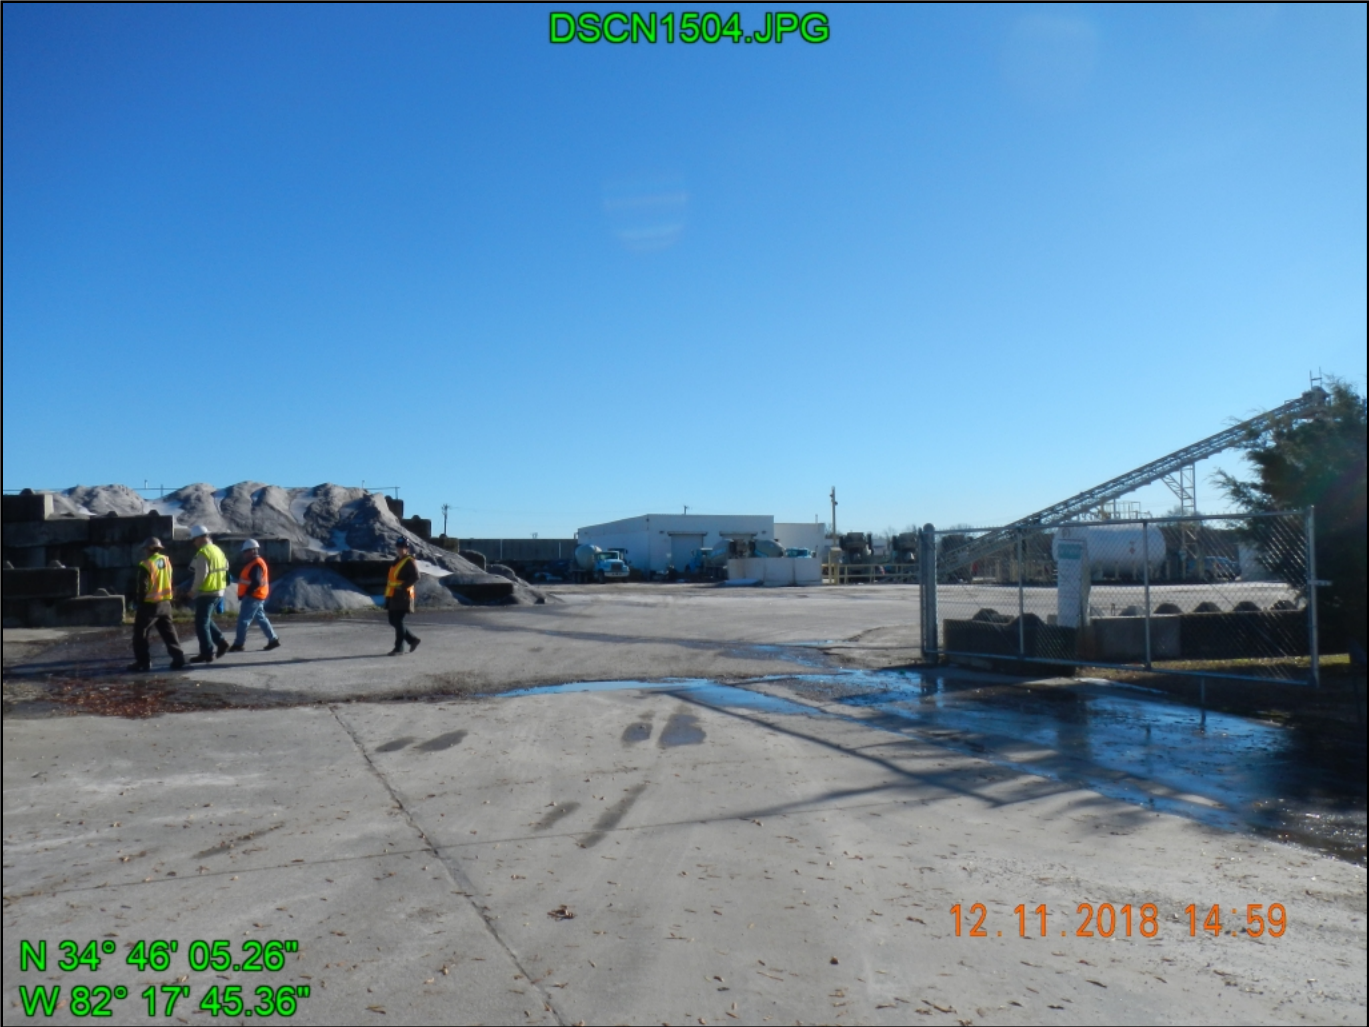
Attributes	
Description	Pile with escaped material and stormwater running off. Drainage flows to the driveway to, and ditch along, Greer Drive.

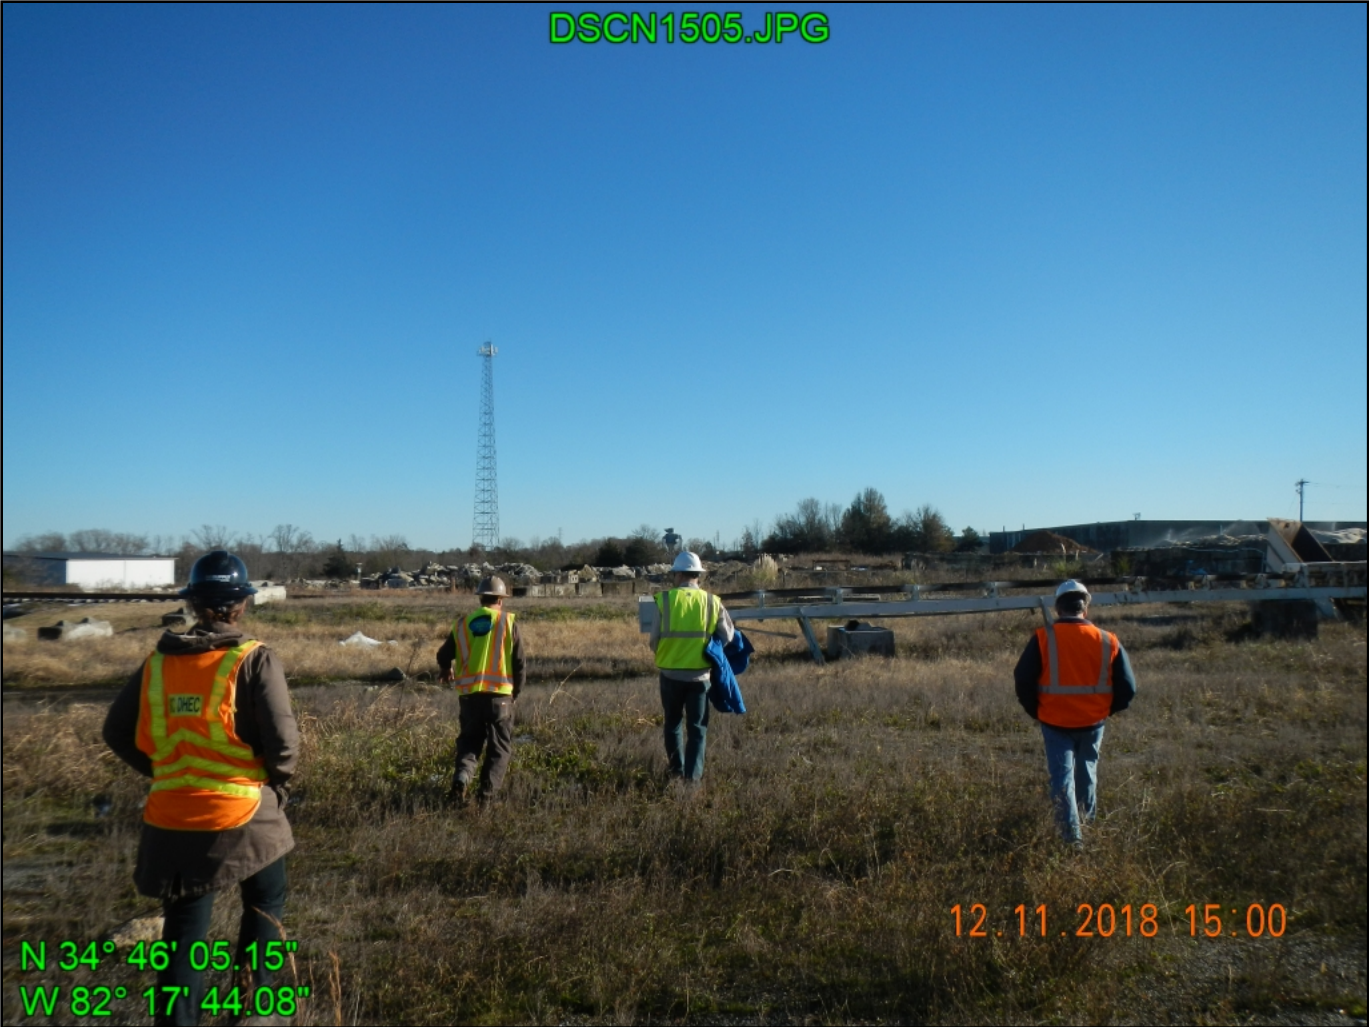
Attributes	
Description	View of concrete recycling area. Walking towards the conveyance to Outfall #1.

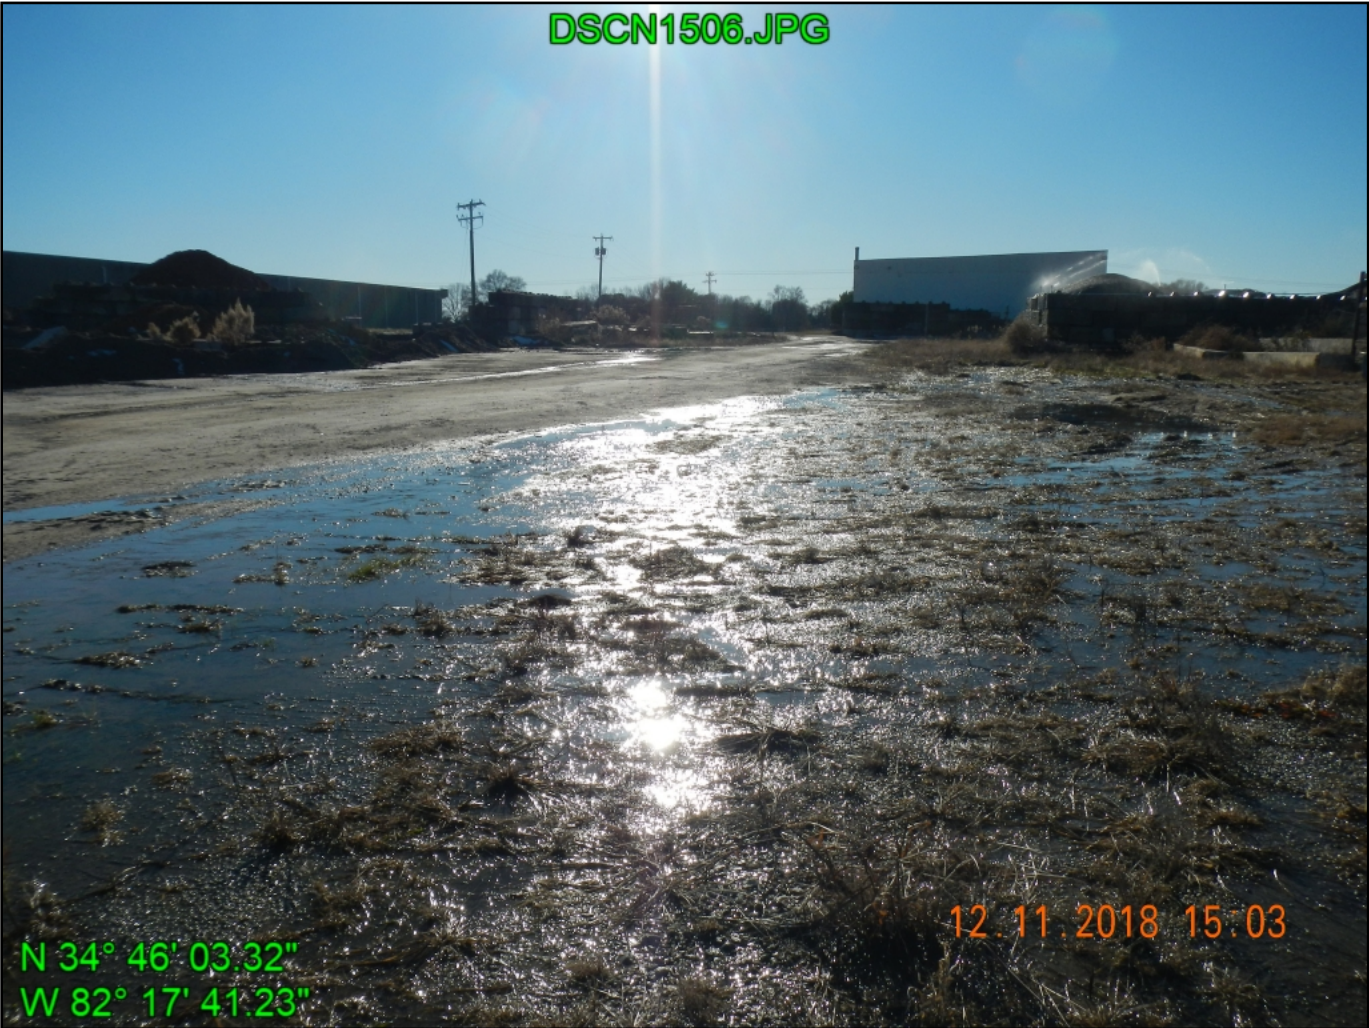
Attributes	
Description	View upgradient of water flowing towards Outfall #1 from the aggregate storage pile. The pile was being watered with city water.

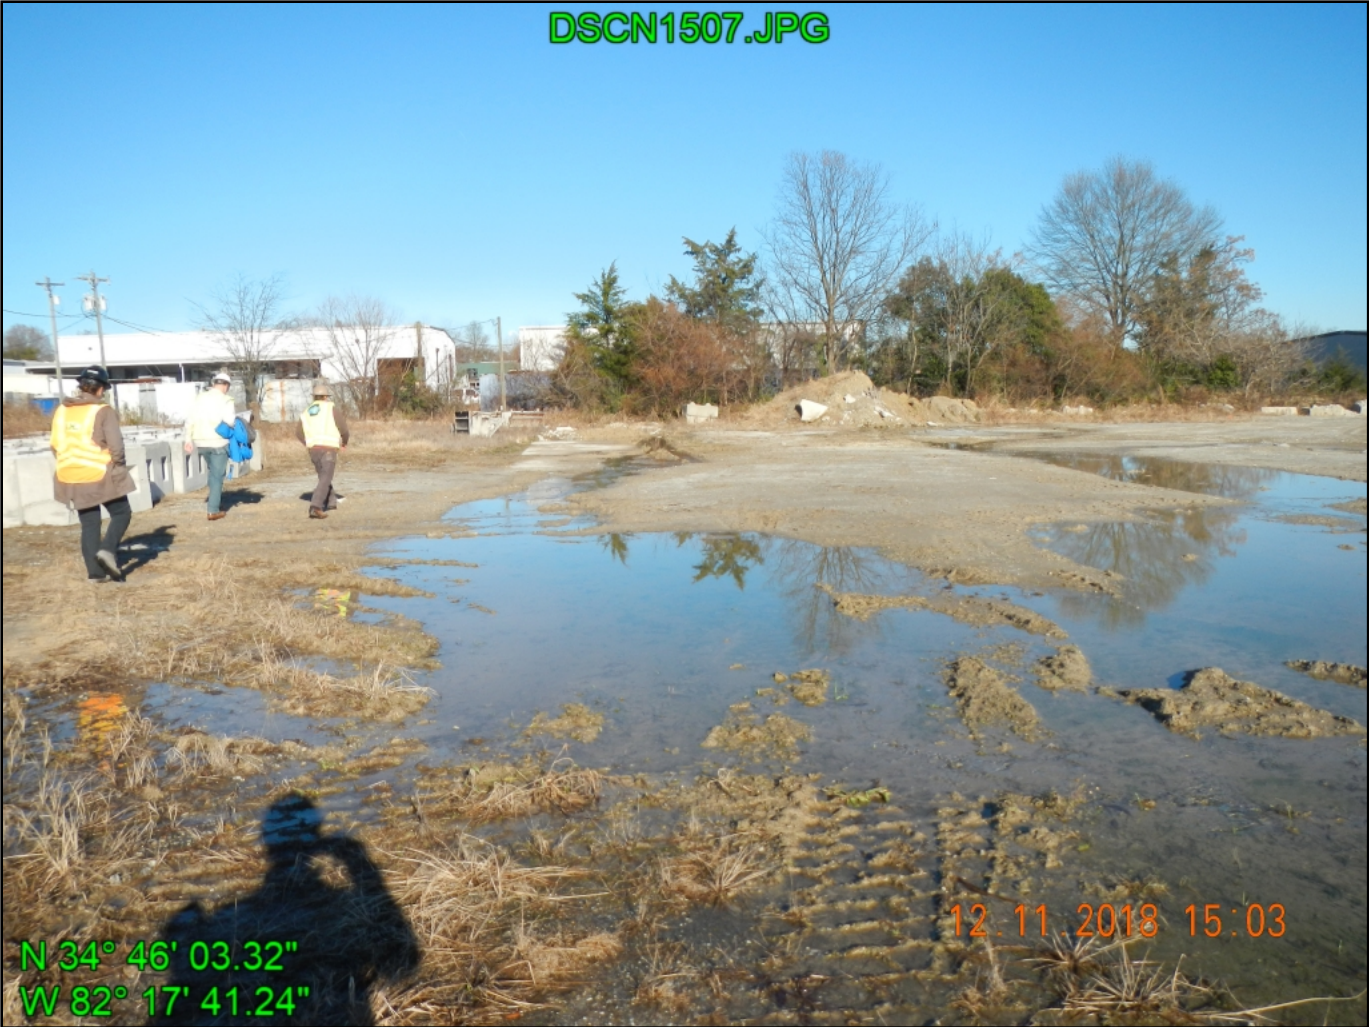
Attributes	
Description	View looking downgradient of water flowing towards Outfall #1 from the aggregate storage pile. The pile was being watered with city water.

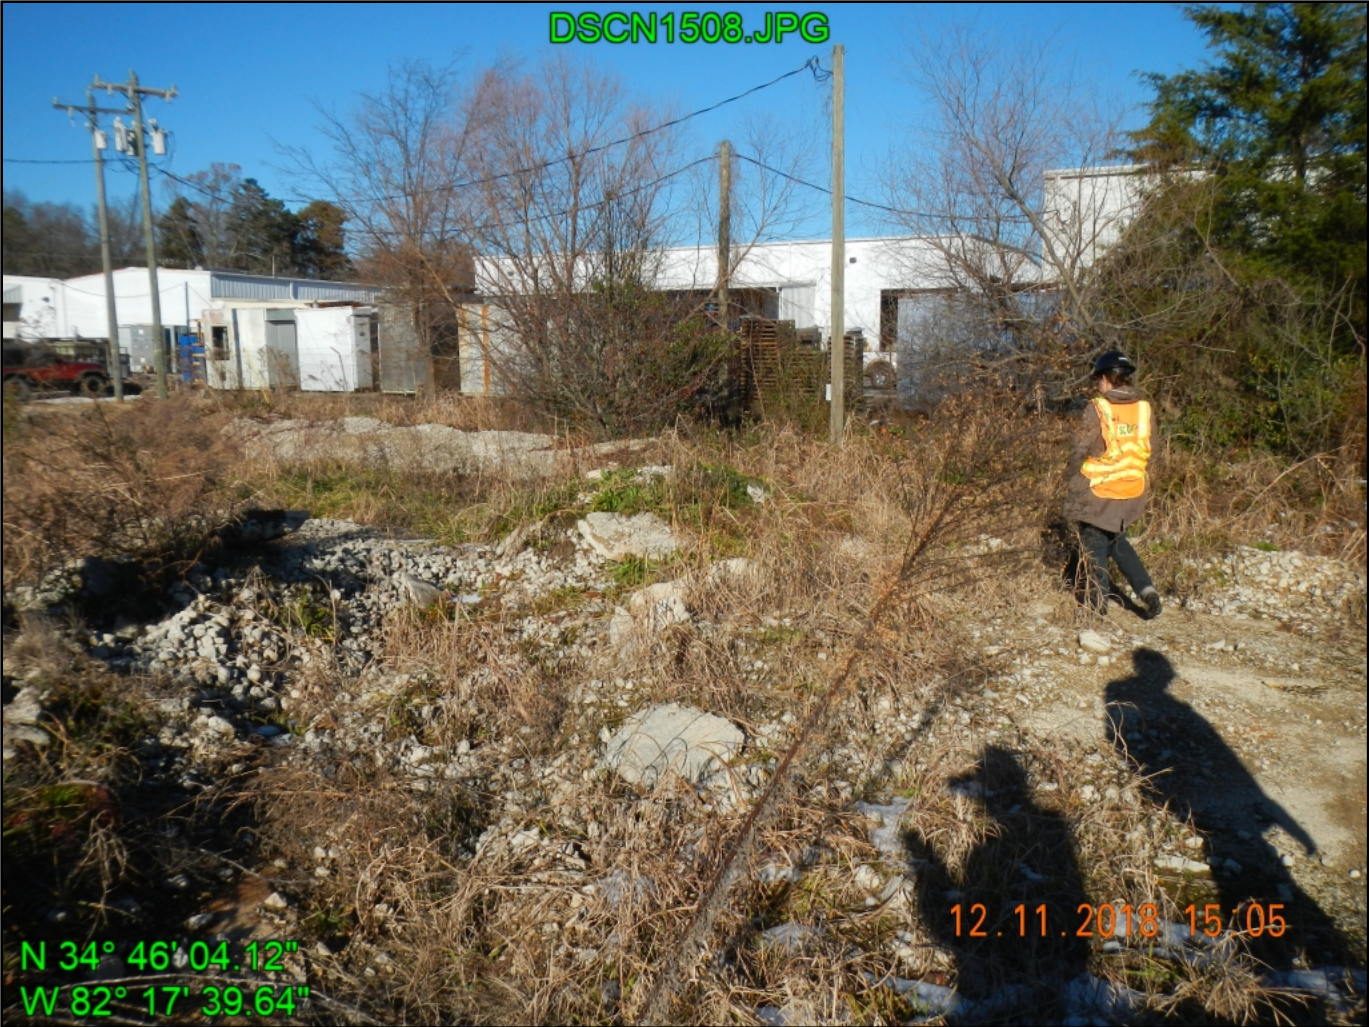
Attributes	
Description	The post in the photo is the approximate location of where the facility used to have Outfall #3. The facility stated that they moved material to block Outfall #3 and no longer treat it as an outfall. The flowing water shown in photo DSCN1507 goes under the concrete slab in the left-center of the photo. The outlet of this conveyance was not readily accessible.

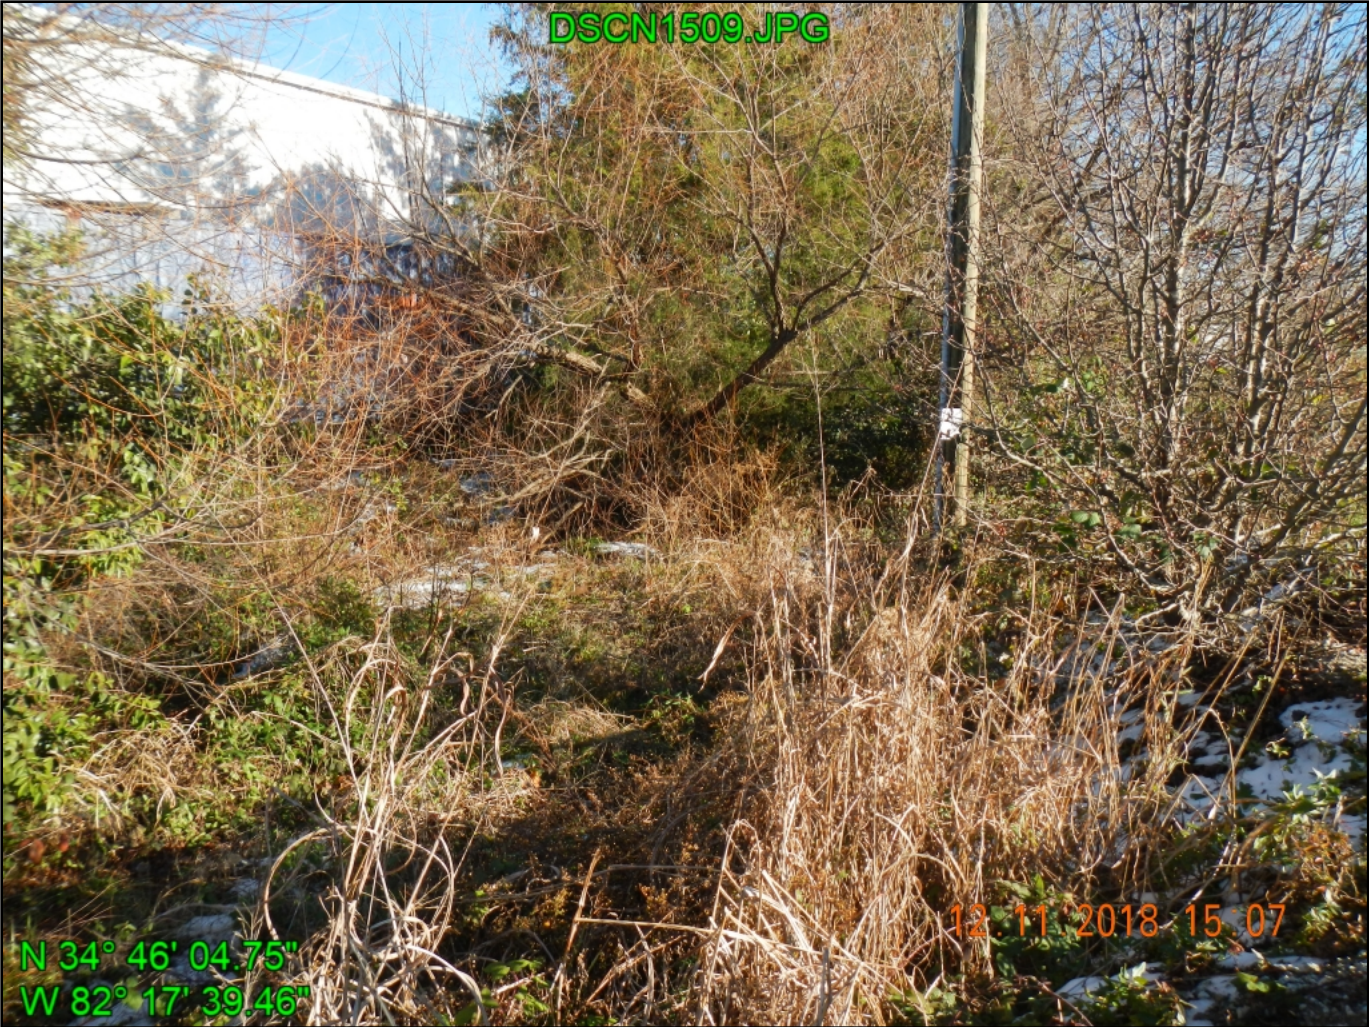
Attributes	
Description	The post in the photo is the approximate location of Outfall #3. Outfall 3 is considered to be unused by the facility. The center of the photo is a vegetated ditch along the NE property line.

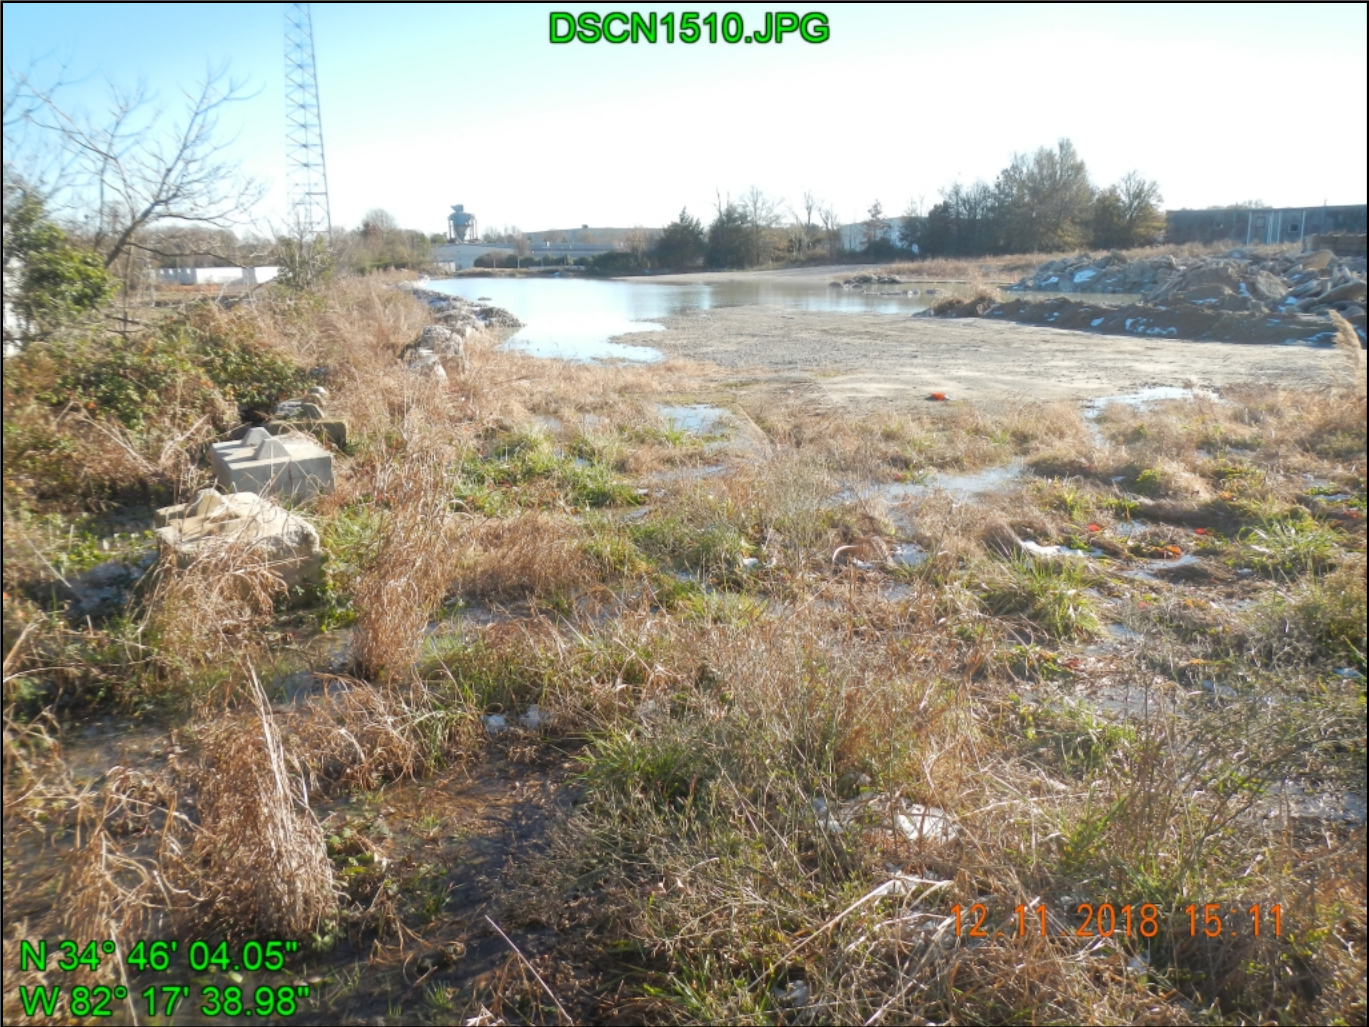
Attributes	
Description	"Returned Concrete Recycling" area with water, on the east side of the facility. Note that the water is nearly at the top of the berm in some locations.

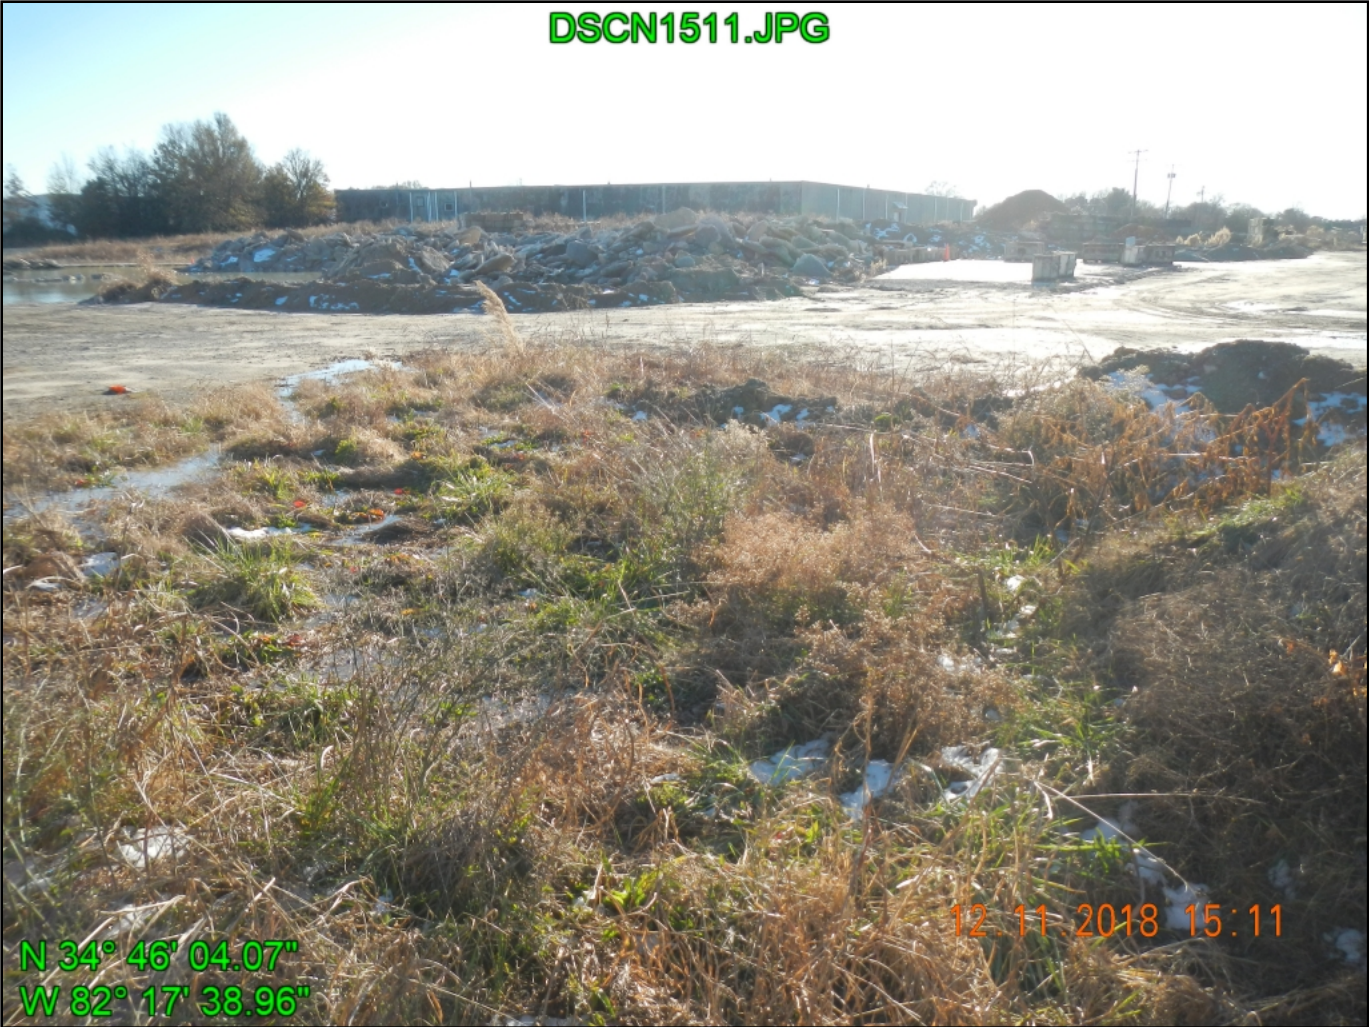
Attributes	
Description	Another view of the Returned Concrete Recycling area.

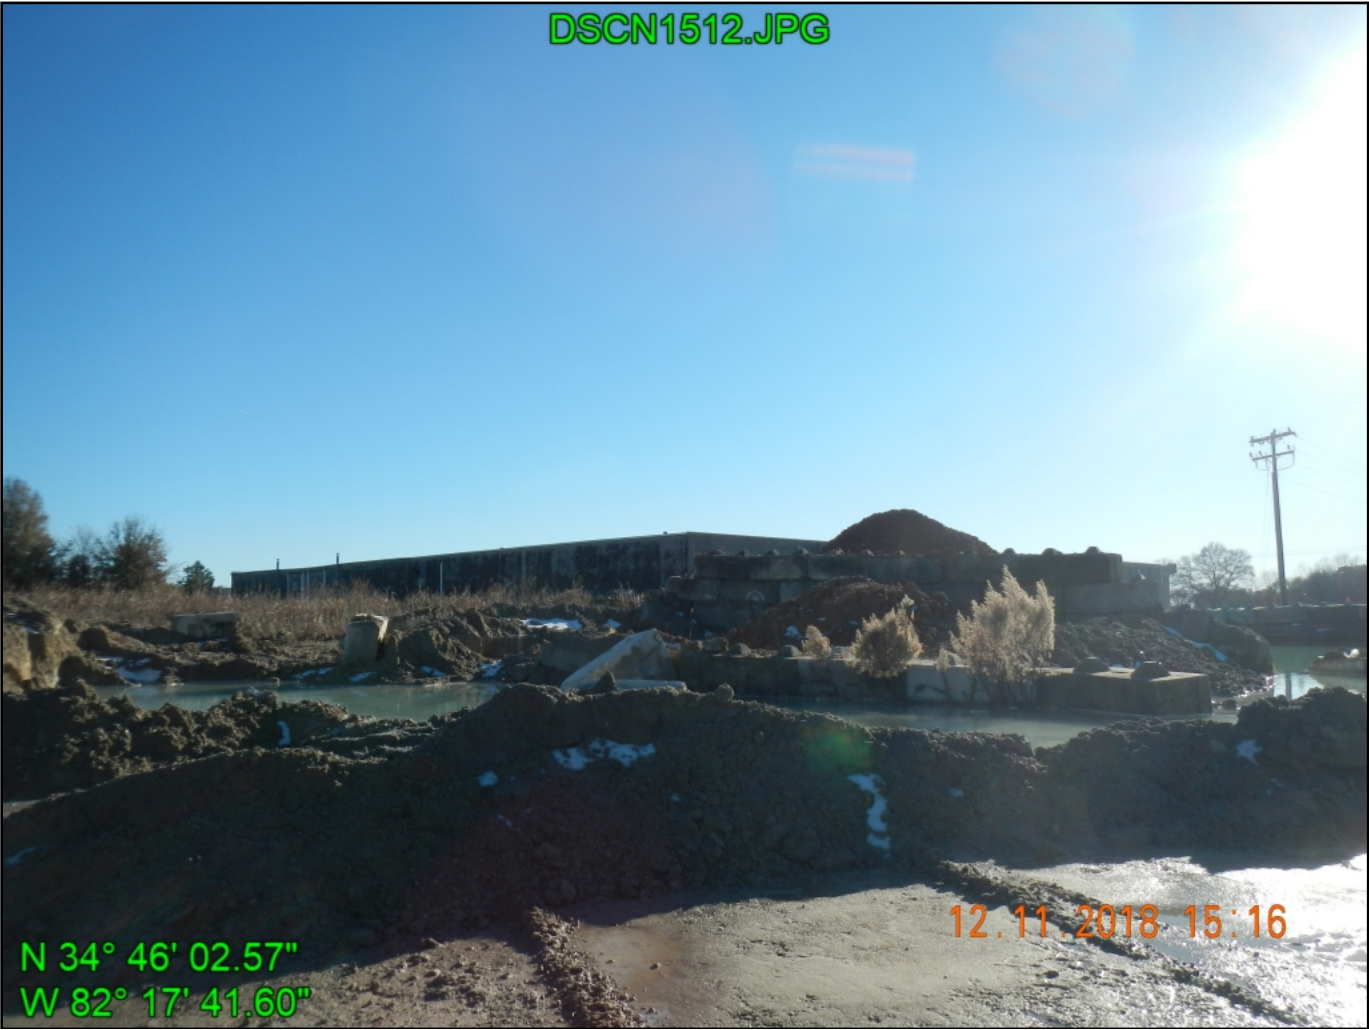
Attributes	
Description	Slurry washout area, northern end.

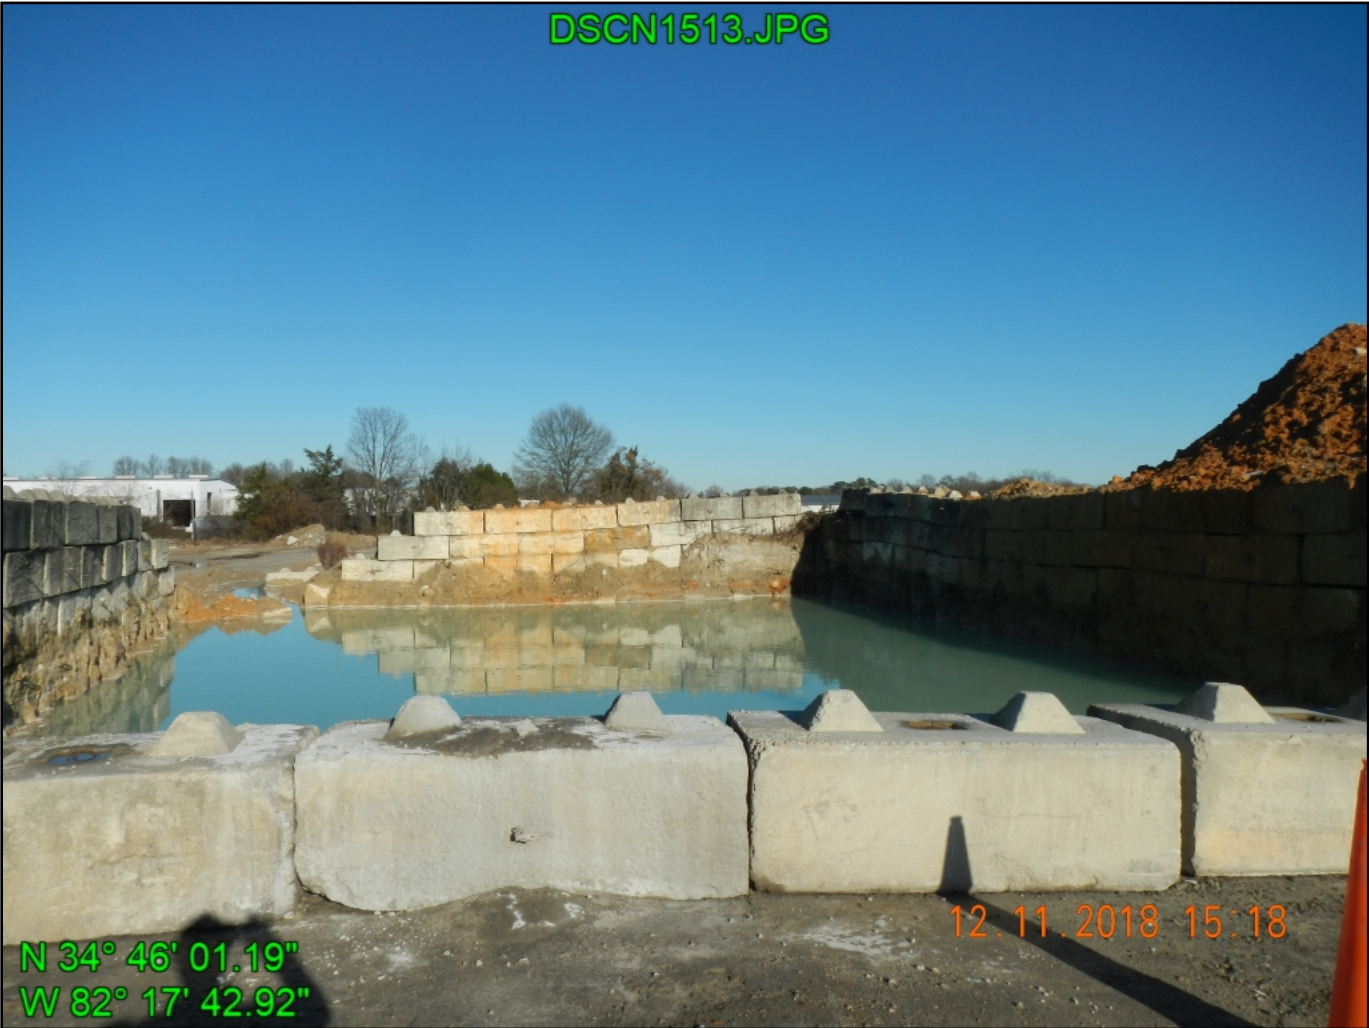
Attributes	
Description	Southwestern side of the slurry washout area. When slurry solids are mucked out, the solids are placed in piles downgradient - see back left in photo.

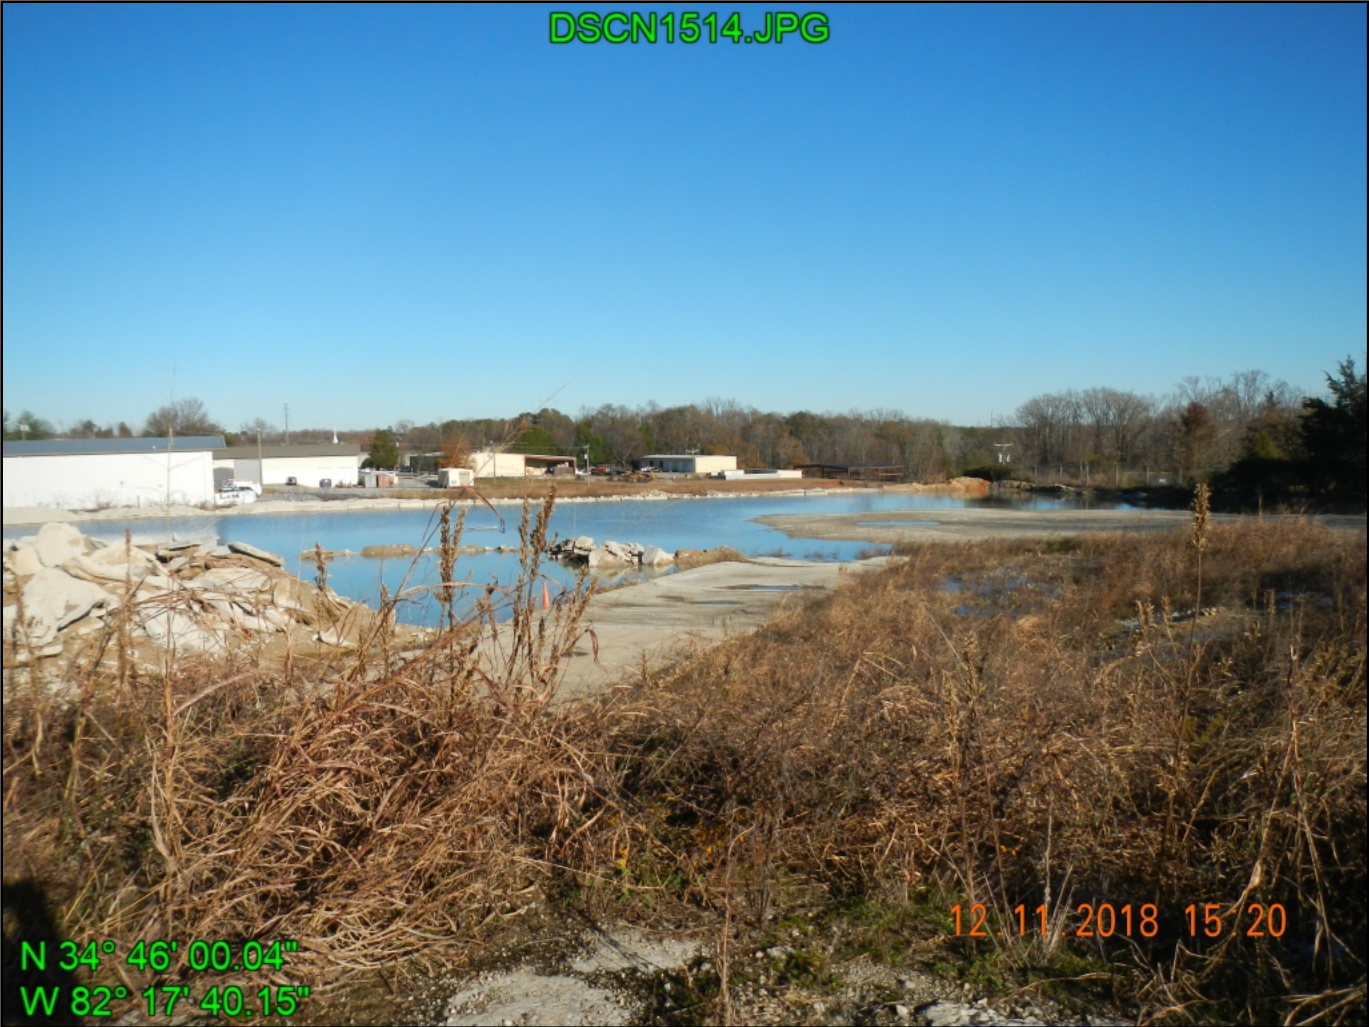
Attributes	
Description	The pond level of the concrete recycling area was near the top of the berm. The adjacent neighbor had complained about water discharge to CSC about a year prior to the inspection, and CSC increased the berm wall height after the complaint.

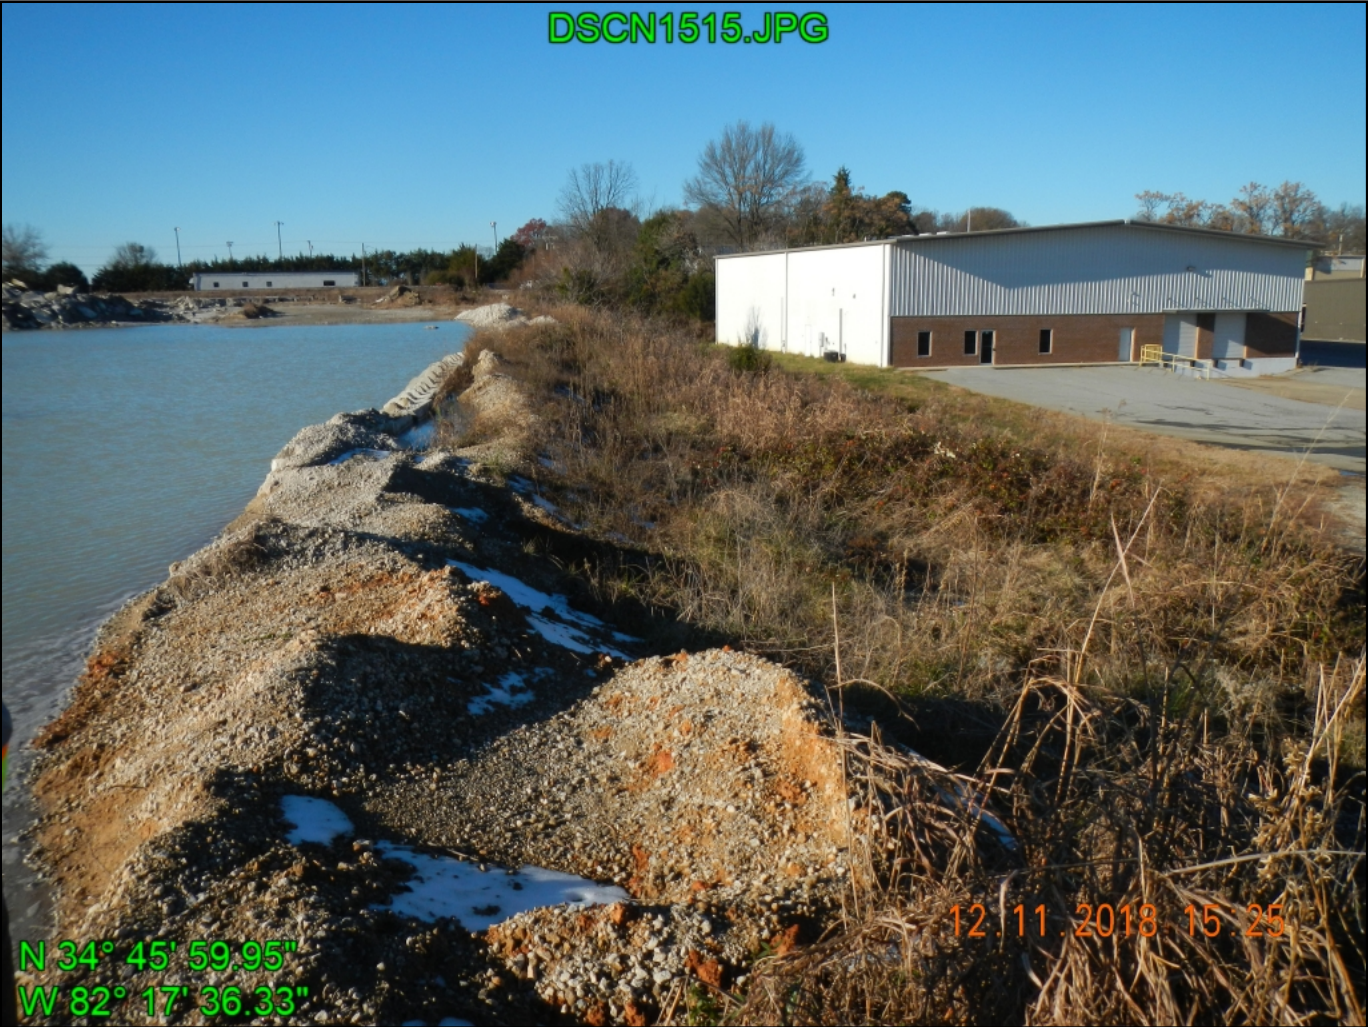
Attributes	
Description	The water in the concrete recycling area pond level is near the top of the berm.

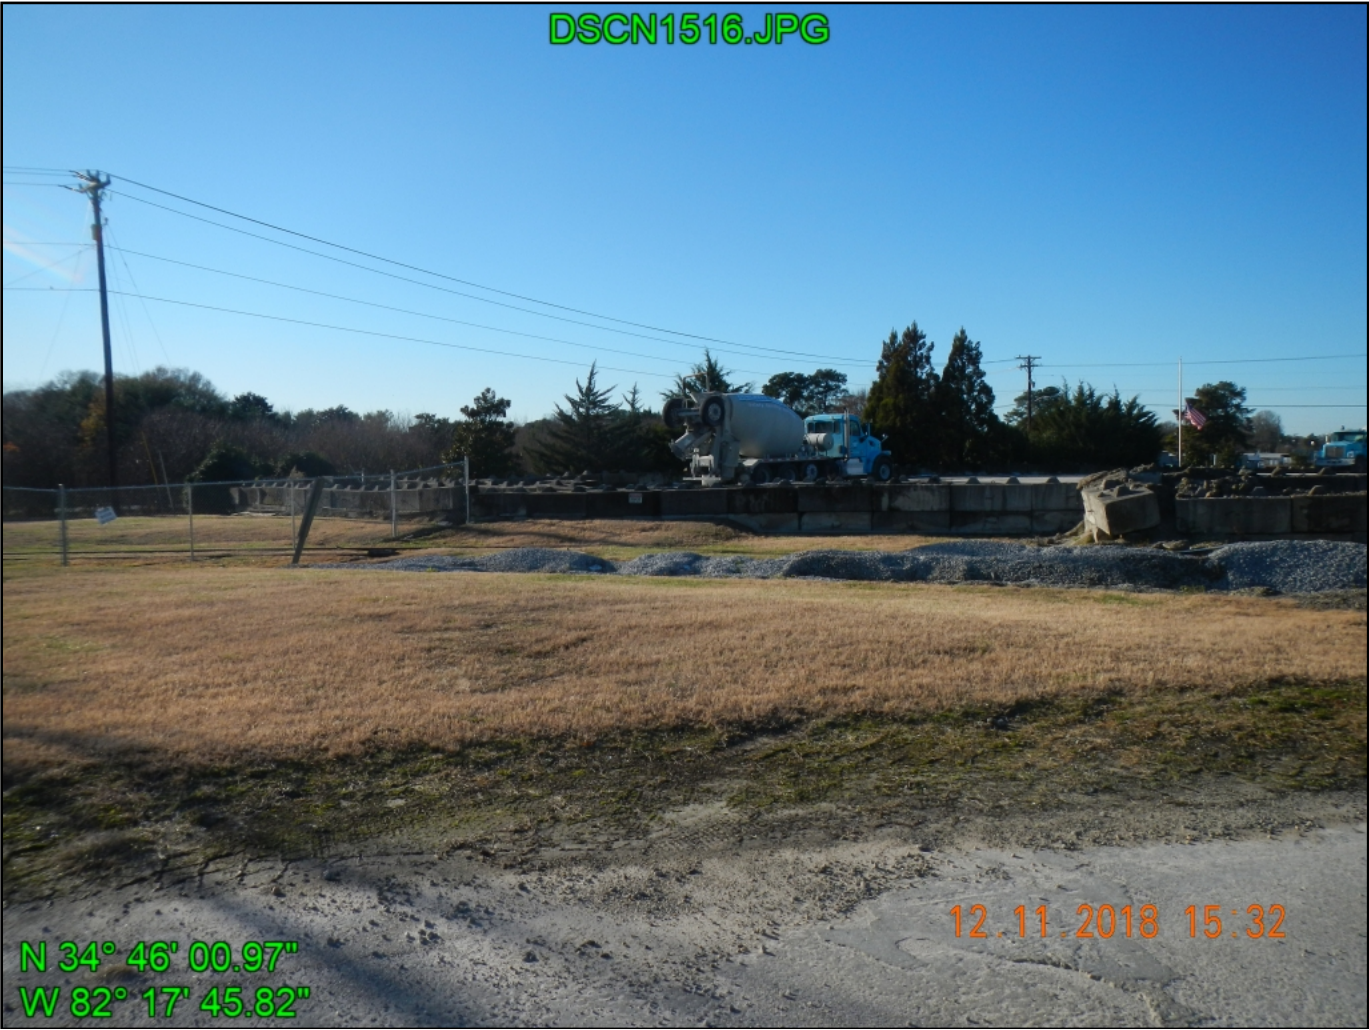
Attributes	
Description	Former rail spur at front of facility. Stormwater Outfall #2 is along that line (gravel, mid-photo).

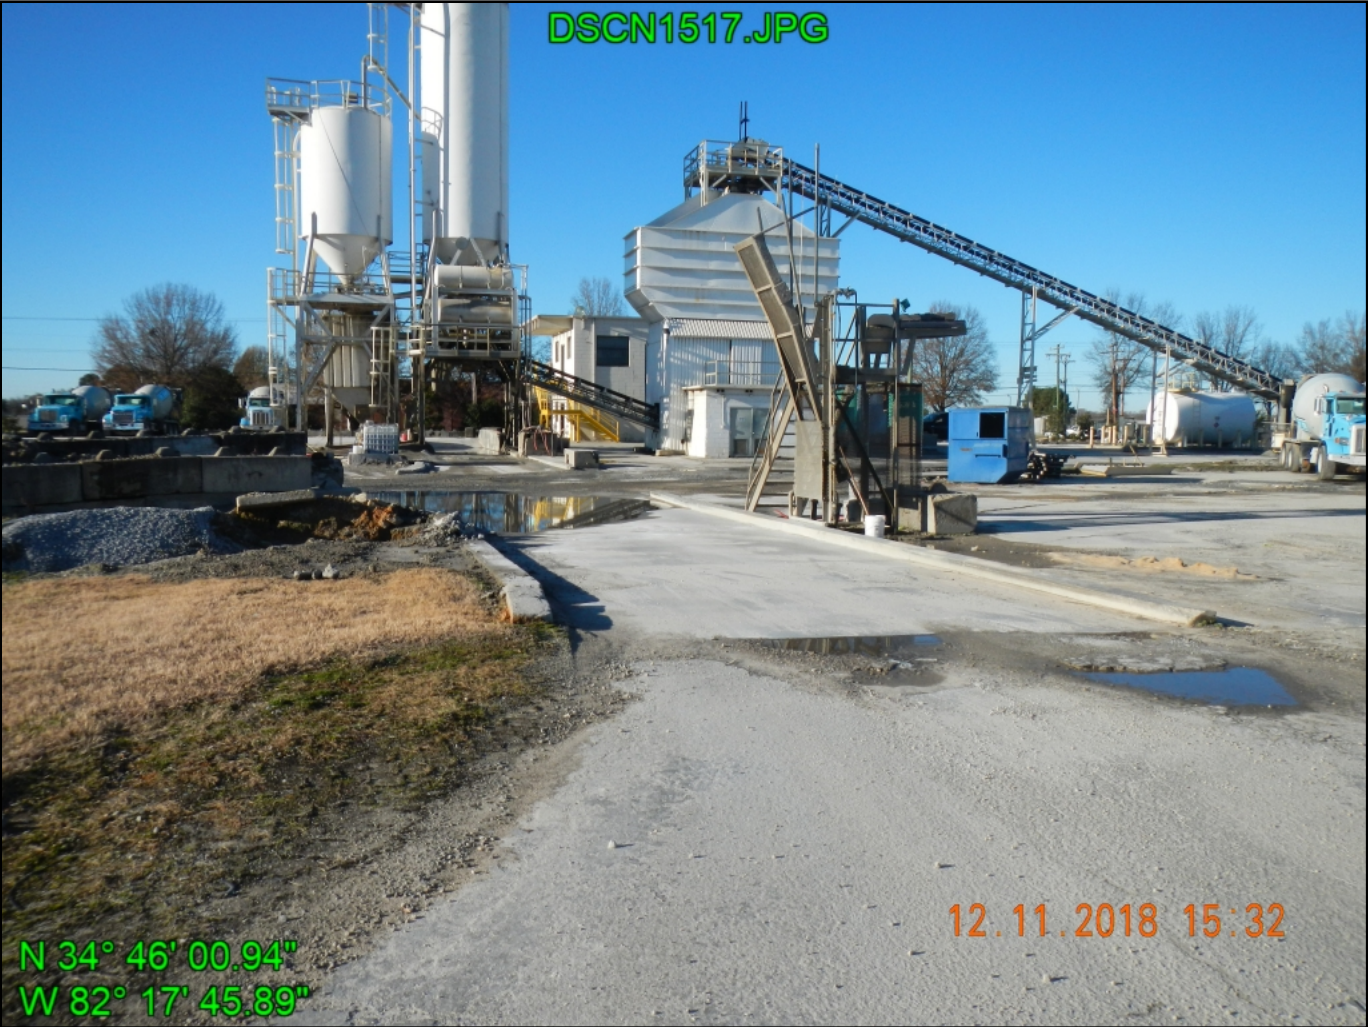
Attributes	
Description	Foreground is truck wash area; ready-mix tower in background.
